August 19, 2009

On Friday, August 14, 2009, Integrated Risk Management Associates, LLC did field inspections at Georgia-Pacific Encadria in Green Bay, Wisconsin and at the Booster Station in Wausau, WI. Our report and recommendations follow:

Georgia- Pacific Encadria, 1100 W. Mason Street, Green Bay, WI 54303

Booster Station, 5918 Old Coach Road, Wausau, WI 53566

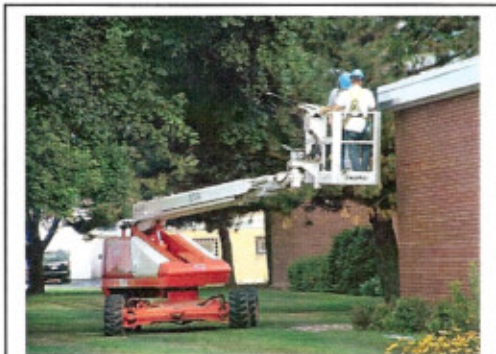
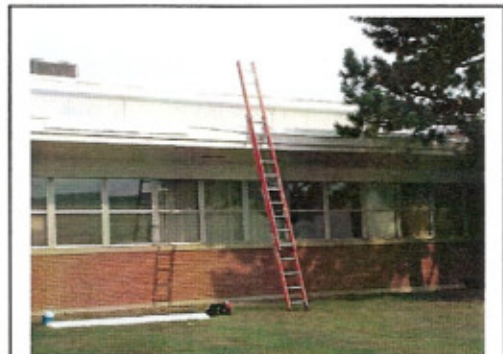
I arrived at Georgia-Pacific at 8:00 am. Eric and Jason were working from aerial-lift DL 1935. They were installing fascia along the edges of a flat overhang roof. Both were properly tied-off in the bucket and both were wearing safety glasses and hardhats. (See Photos 1& 2)

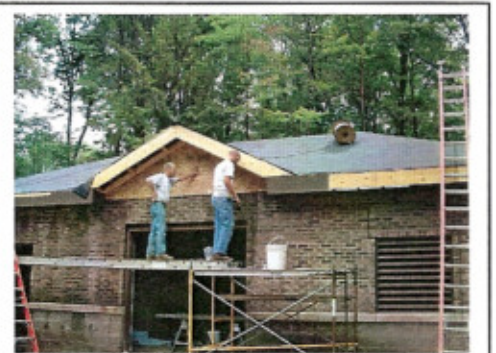
Photo 3

Tyler and Jim were working from a scaffold set up at the front of the station. The scaffolding was only 5 feet high, therefore, fall protection was unnecessary. (See Photo 3)

1926.451 (g) Fall protection. (1) Each employee on a scaffold more than 10 feet (3.1 m) above a lower level shall be protected from falling to that lower level.

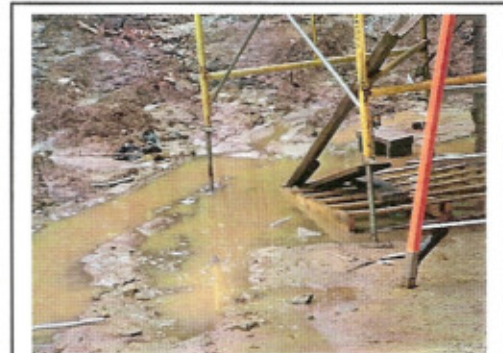
Photo 4

It had just rained and one of the scaffold legs was sinking into the mud. I advised that a mud-sill be installed on this leg (See Photo 4).
