On Wednesday, June 24, 2009, Integrated Risk Management Associates, LLC did a field inspection at Wal-Mart in Kenosha, Wisconsin. Our report and recommendations follow:

Wal-Mart, 6414 38th Street, Kenosha, WI

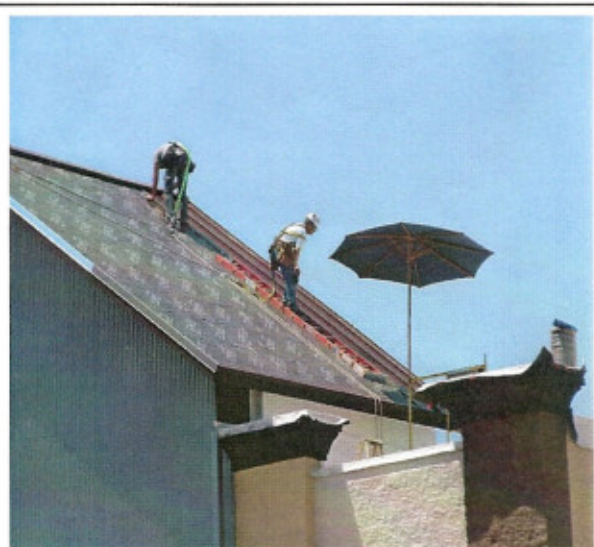
Photo 1

Eric Bertrand and three employees were working on a steep pitch roof on the South side of the building (Photos 1 & 2), and Travis and another employee were working on an overhang in the center of the building (Photos 3 & 4). Two sections of scaffolding (10 feet) were installed on the roofs of both locations. Scaffolds were on casters resting on plywood bases. An eight foot parapet to a flat roof surrounded each of the scaffold assemblies.

Employees working on the steep-slope roof were properly harnessed, and had both a grab-line and chicken ladder properly installed.
